Rapid Inventory of Earthquake Damage (RIED)

The 25 January 1999 Quindío earthquake in Colombia was a major disaster for the coffee-growing region in Colombia. Most of the damage occurred in the city of Armenia and surrounding villages. Damage due to earthquakes is strongly related to topographic and subsurface geotechnical conditions underneath structures and houses. The RIED project used aerial photographs to obtain a rapid inventory of the earthquake damage right after the seismic event. This inventory was subsequently used to identify any existing relation with subsurface- and topographic conditions.

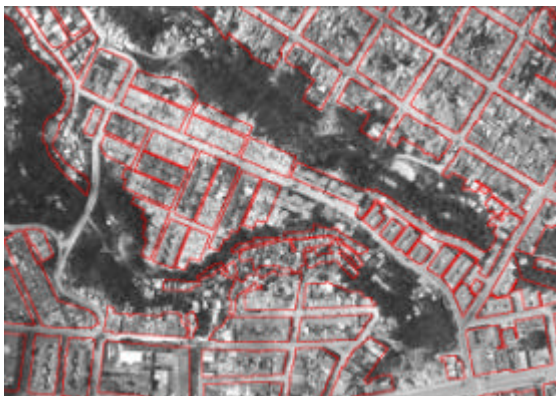
Figure 2. Digital orthophoto combined with existing cadastral data in the GIS

The aerial photographs were ortho-corrected (removal of camera- and topographic distortion) and with existing cadastral and topographic information a comprehensive Geographic Information System (GIS) database was set up in a short amount of time. The aerial photographs were interpreted in order to assess for each individual house or building whether it was damaged and what type of damage

was inflicted (see Figure 2). The damaged structures have been classified and marked on aerial photographs and simultaneously imported in a GIS. Maps for various types of damage to structures have been made and analyzed. In this way a large database was constructed with in total more than 33000 observations. An example of an analysis carried out on the basis of this damage inventory is given in Figure 3.

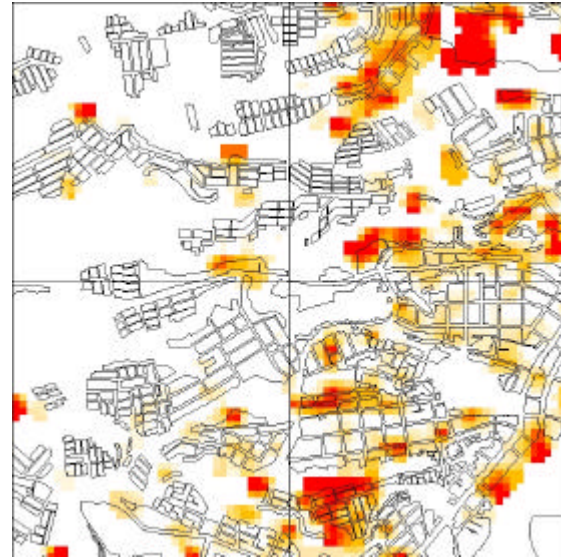
Figure 3. Damage intensity (damaged buildings as percentage of the total number of buildings)

The damage inventory made by aerial photographs clearly shows that the damage is concentrated in a more or less wedge-shaped area bounded by the Armenia fault on the East side and by alignments in the topography on the West side. The coincidence of this alignment with the boundary of the most damaged areas may indicate that the alignment in the topography is in fact a fault trace. The damage inventory shows further that topographical effects are of important influence on the damage inflicted on the surface structures. The apriory assumed influence of the landfills on the damage of structures is less obvious from the inventory by

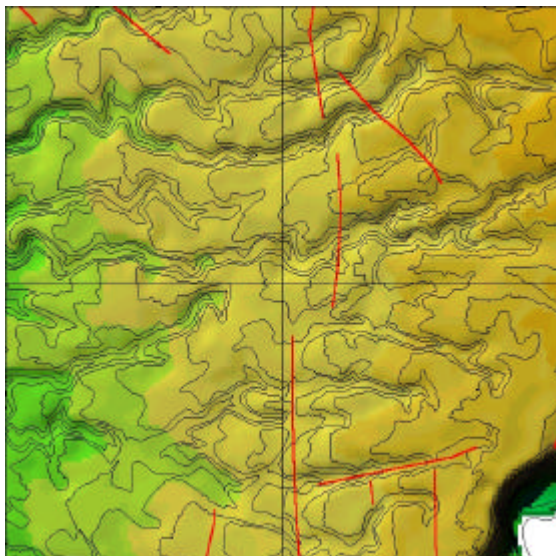
Figure 4. Topographic relief

The presence of topographic undulations (Figure 4) has a marked influence on the surface accelerations of an earthquake. Near steep slopes an amplification of the effects of an earthquake can be expected. Also resonance effects are possible if the dimensions of ridges in the topography coincide with the frequencies of the major tremor of the earthquake. The locations where this resonance effect may take place has been modeled in the GIS and an example of this analysis is given in Figure 5. Both topographic effects can be correlated to the damage patterns of the city of Armenia.

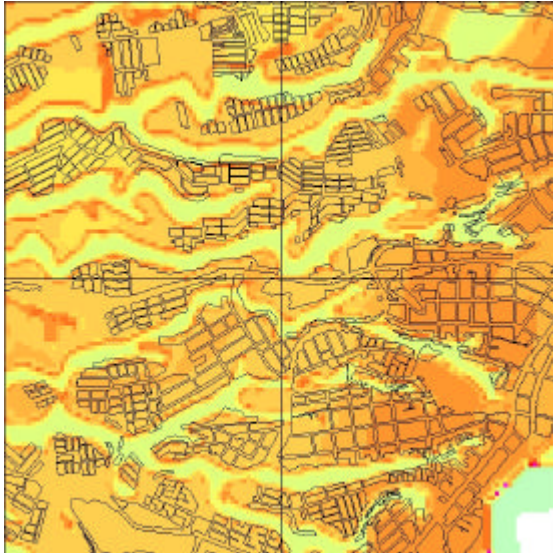
Figure 6. *Seismic acceleration response distribution for 1-2 story buildings*

model was constructed in the GIS which was subsequently used as input for the seismic response model. On the basis of the results of this seismic response analysis different seismic microzonation maps have been made which delineates the difference in seismic responses throughout the area as a function of the subsurface geology. Examples of these microzonation maps are given in Figures 6 and 7.
