The role of remote sensing and GIS in risk mapping and damage assessment for disasters in urban areas

Dr. Cees J. van Westen & Drs. Paul Hofstee
International Institute for Aerospace Survey and Earth Sciences (ITC)
P.O. Box 6, 7500 AA Enschede, The Netherlands
Email: westen@itc.nl, hofstee@itc.nl

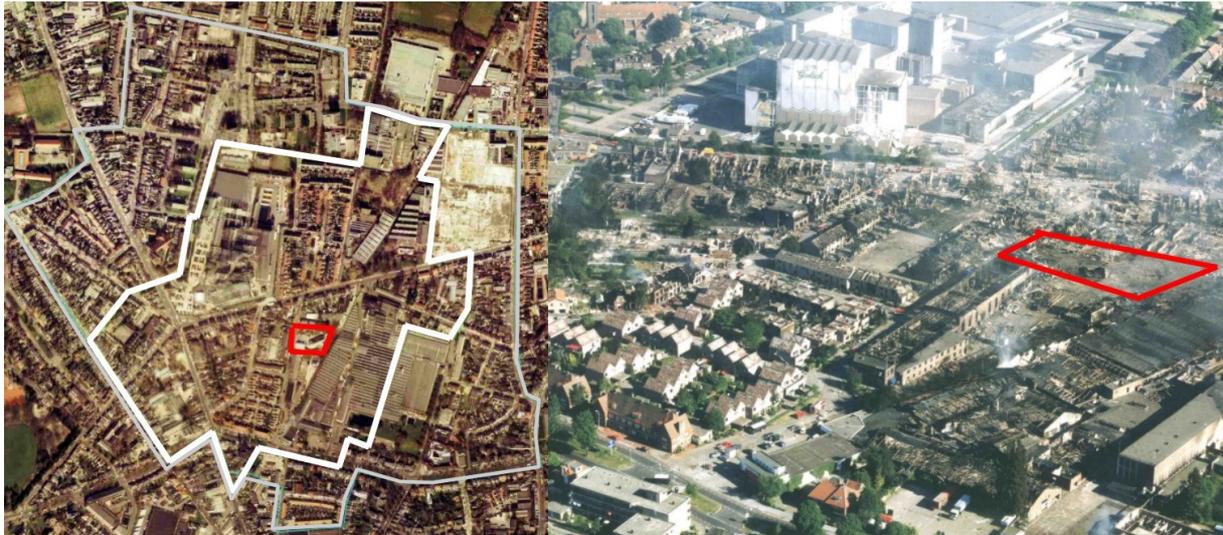
Figure 1: Left: Mosaic of vertical colour aerial photos of the disaster area, taken on March 30, 1998. Annotated with firework storage area in red, and two rings of affected areas. The so-called “inner ring”, with complete destruction indicated in white, and the “outer-ring”, with large damage in gray. (Source: Municipality of Enschede, Bouw en Milieudienst). Right: Oblique aerial photo of disaster area one day after the explosion. (Source: KLPD, Korps Landelijke Politie Diensten).

On 13 May 2000 at 15.35 a firework storage exploded in the centre of the city of Enschede, located in the East of the Netherlands along the border with Germany. The firework company, which was specialised in professional fireworks for large events, was located in the middle of a residential area (See figure 1). The affected area covered more than 40 ha with 6500 inhabitants. Direct consequences included 22 persons killed, more than 900 wounded, and at least 290 dwellings damaged beyond repair (see table 1). After the disaster a great demand for geo-information emerged.

A distinction was made between the “inner ring” area (40 ha and quickly completely closed for non-authorized persons by a wooden fence) and the “outer ring” area (about 1 km², the less severely damaged area)(see Figure 1).

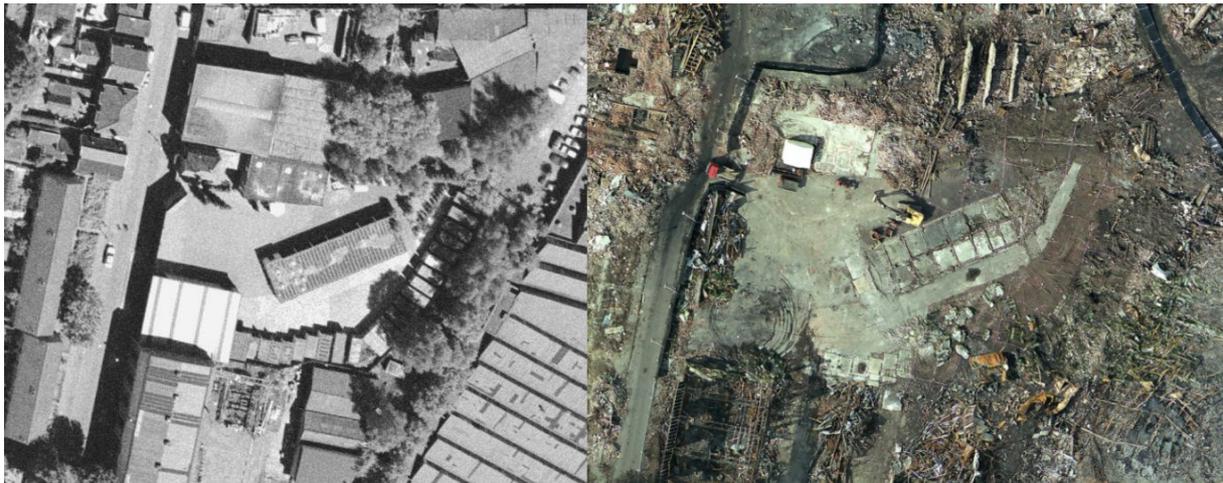
Figure 2: The firework storage site. Top: Vertical 23 black&white aerial photo (scale 1:18.000) taken 4 hours before the explosion (Source: Topografische Dienst Emmen). Below: Vertical colour aerial photo (scale 1:1000) taken on 25 May (Source: Municipality of Enschede).

Twelve days after the explosion a series of 9 vertical aerial photos (scale 1:1000) was made of the disaster area, ordered by the municipality, showing fine details of the area. The explicit purpose of these images, forming a photo mosaic of the total area, was to document (or “freeze”) the situation at the date of transfer of the responsibility for the disaster area from the RIT (disaster identification team) to the municipality (see figure 2).

- Vertical black & white aerial photos, scale 1: 18,000, date 13 May 2000 (made every 5 years for updating topographic maps). This set of photos was as usual planned in springtime and was coincidentally made just 4 hours before the explosion (see figure 2). The photos were used in particular to count the number of seacontainers and boxes used to store firework materials, because the storage system and the maximum quantities stored are specified in the legal permission of the company.

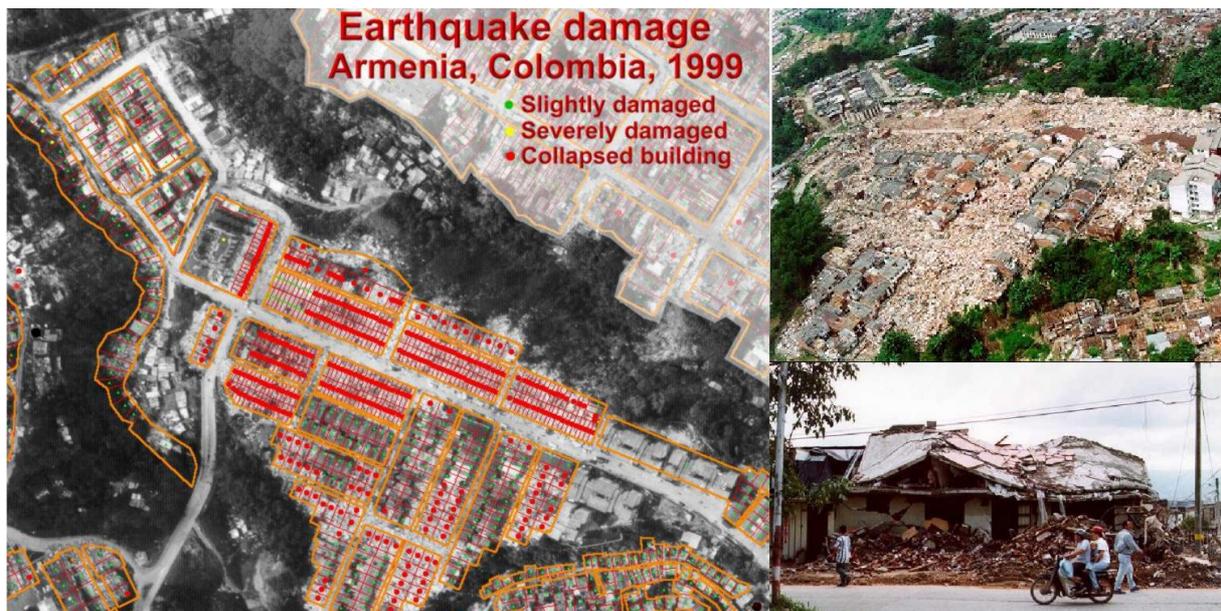
Figure 3: Left: Orthophoto made with aerial photographs of 1999, taken few days after the earthquake, overlain by the city blocks and point map indicating damaged buildings of Barrio Brasilia in Armenia. Upper right: Oblique aerial photo of the same area. Lower right: Field-photo showing example of roof collapse.

Aerial photograph interpretation was carried out in order to find the buildings, which were affected by the earthquake and had different levels of damage. The following damage classes were used: total collapse, roof collapse, roof partly damaged, and no visible damage, but rubble in street. The damaged buildings were drawn by hand on transparent sheets as points with different colours according with the level of damage. The points were digitised afterwards in GIS to create a point map, which was used in combination with a set of orthophotos and a cadastral vector database (see figure 3). The damage inventory made from aerial photographs clearly showed that the damage was concentrated in a more or less triangular area bounded by the Armenia fault on the East side and by a topographical alignment on the West side, which could be mapped from aerial photographs. The coincidence of this alignment with the boundary of the most damaged areas may indicate that the alignment in the topography is in fact a fault trace. The damage inventory showed further that topographical effects have been of major influence on the damage inflicted on the buildings. The a-priori assumed influence of the presence of landfills on the damage patterns is less obvious from the damage inventory by aerial photo-interpretation. The city of Armenia is constructed on top of a heavily incised alluvial fan, and most of the stream incisions have been filled up by landfill. This indicates that the influence of the landfills for the characteristics of the earthquake shockwave of January 1999 is less severe than was assumed.

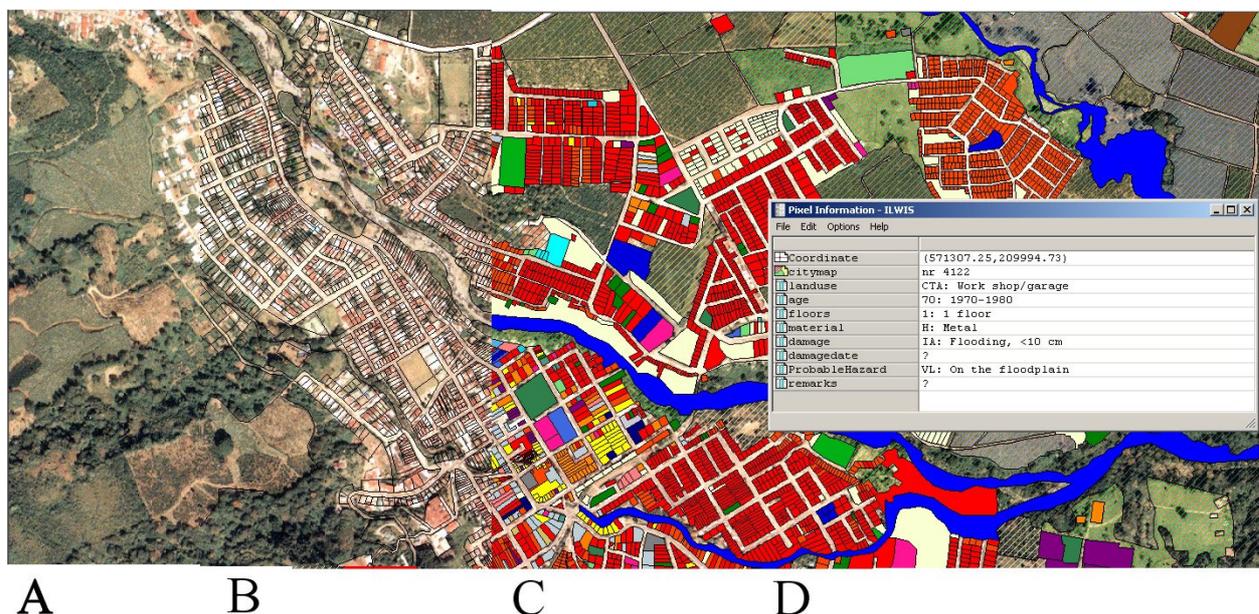
Figure 4: Different views of the large-scale database for the city of Turrialba. A: orthophoto, B: vector overlay of parcels, C: polygons displaying landuse type, D: reading information from the attribute database.

In order to assist the local emergency commission and the municipality, a series of color aerial photographs has been used with a scale of 1:40,000, which were scanned with high resolution and combined with a Digital Elevation Model and a series of ground-control points for the generation of an orthophoto-map (See Figure 4). On the orthophoto all buildings within the city and its direct surroundings were digitized, as well as the land parcels, and the roads and other infrastructures. This resulted in a digital parcel map, consisting of 7800 polygons.
