Landslide dams triggered by the Wenchuan Earthquake, Sichuan Province, south west China

Abstract At 14:28 (Beijing time) on 12 May 2008, the catastrophic Ms 8.0 Wenchuan earthquake occurred just west of the Sichuan basin, China, causing severe damage and numerous casualties. It also triggered a large number of landslides, rock avalanches, debris flows etc. Some of the landslides formed natural dams in the rivers, with the potential secondary hazard of subsequent flooding. Through the interpretation of a series of aerial photographs and satellite images, 256 landslide dams were identified, although because of limited access, relatively detailed data were available for only 32. The paper presents statistical analyzes of the distribution, classification, characteristics, and hazard evaluation of these 32 dams. A case study of the $2.04 \times 10^7 \text{ m}^3$ Tangjiashan landslide dam and the emergency mitigation measures undertaken is discussed.

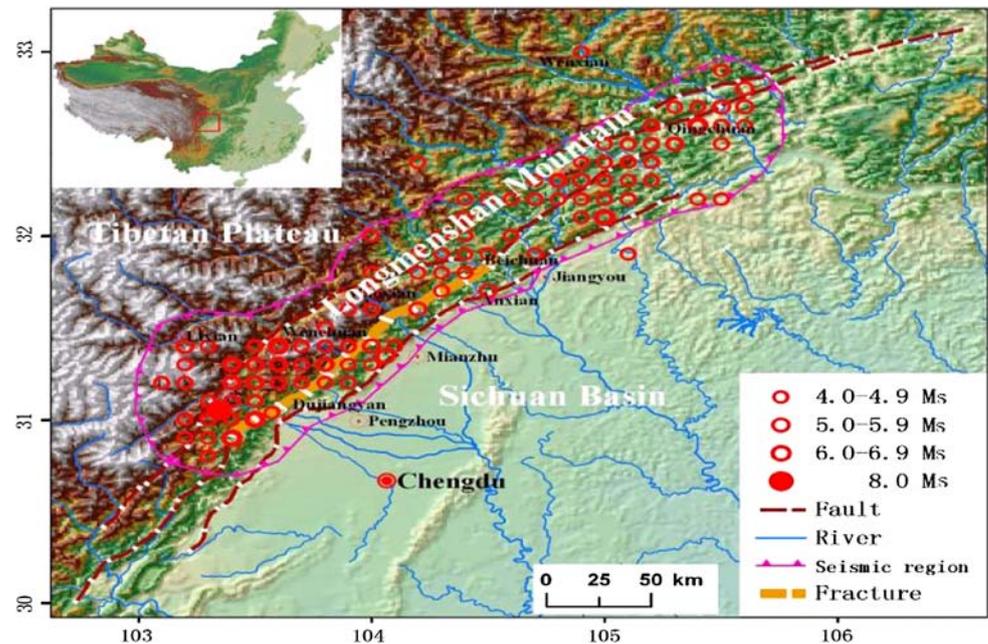
Fig. 1 The Longmenshan fault zone related to the Ms 8.0 Wenchuan earthquake

trending Longmenshan fault zone at the eastern margin of the Tibetan Plateau, just west of the Sichuan basin, China (Fig. 1). The Longmenshan fault zone is a tectonically active region, with three faults: the Wenchuan–Maowen fault, the Yingxiu–Beichuan fault and the Pengguan fault. The Yingxiu–Beichuan fault is the main fault that induced the earthquake. This devastating earthquake was the largest and most destructive movement in this densely populated mountainous area in the last 100 years and caused numerous landslides, rock avalanches, debris flows etc. One type of natural hazard can induce other hazards (the domino effect), which makes research on natural hazards much more complex and difficult. For example, a co-seismic landslide can block a river and form a landslide dam, which may burst and cause a catastrophic flood.

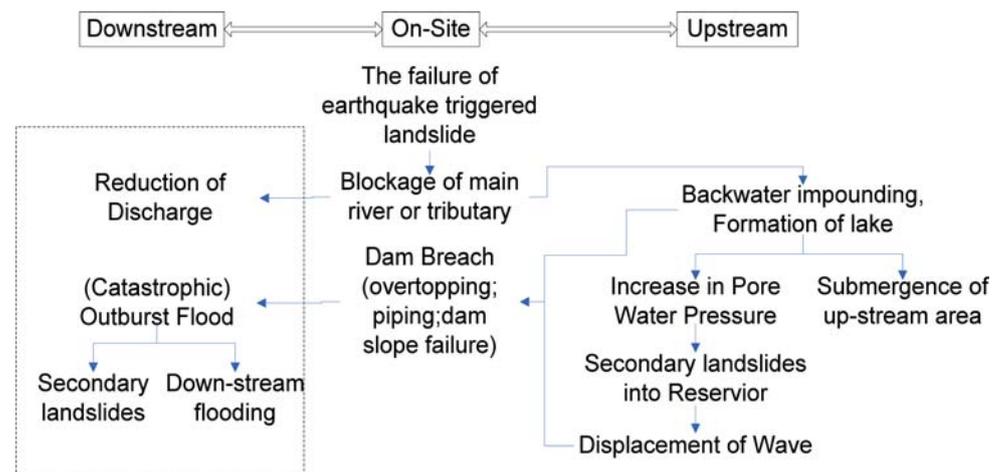
Fig. 2 Hazards caused by the formation and failure of landslide dams triggered by the Wenchuan earthquake using a modified version of Korup's (2005) model; the geomorphic hazard is not included

Figure 2 shows that a barrier lake generated by a landslide dam will submerge the upstream area and subsequently cause an increase in pore water pressure in the adjacent strata, which may induce secondary landslides into the lake. As a result, a displacement wave might be generated and may force the failure of the dam, in turn producing flooding in the downstream area and a high potential for the triggering of secondary landslides.

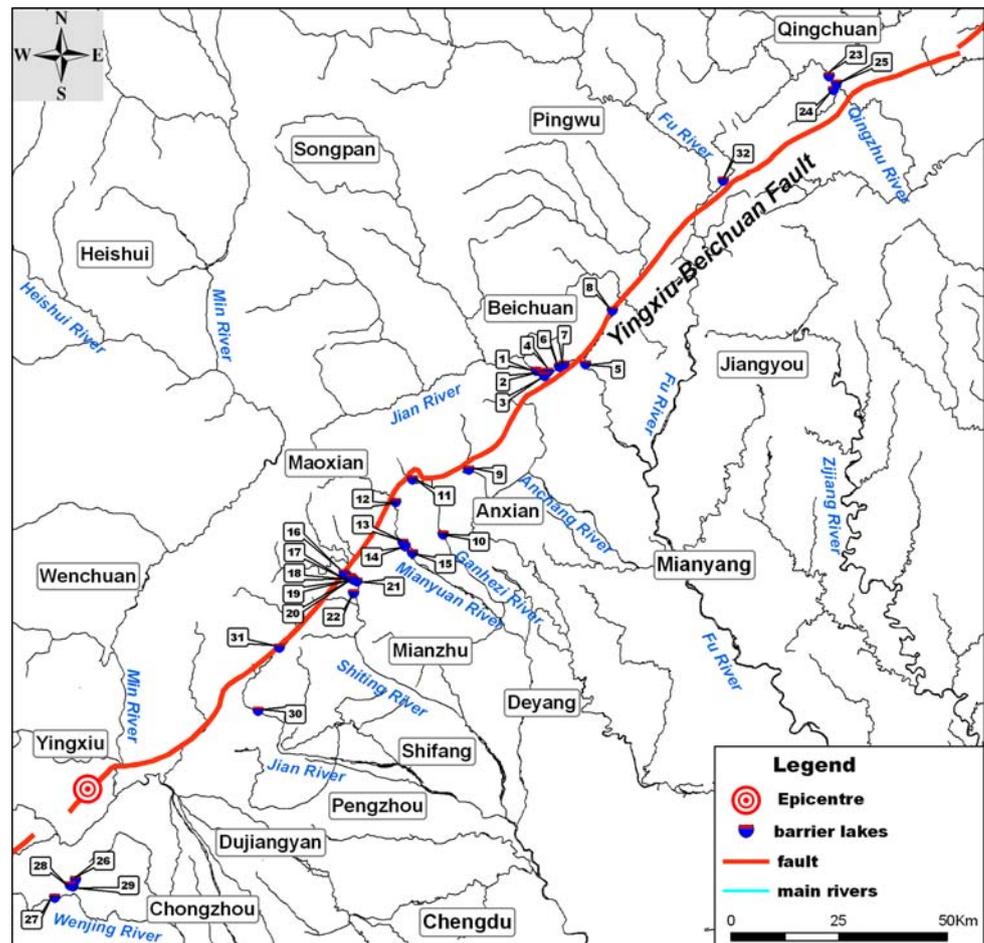
Fig. 3 Locations of the 32 earthquake-induced landslide dams and surface expression of the Yingxiu–Beichuan fault

As seen in Fig. 3 and Table 1, eight of the landslide dams are along the Jian River in Beichuan; three along the different tributaries of the Pei River in An county; four along the Mianyuan River in Mianzhu; seven along the Shiting River in Shifang; three along the Qingzhu River in Qingchuan; four along the Wenjing stream, a tributary of the Min River, in Chongzhou; two along the Shajin stream, a tributary of the Tuo River, in Pengzhou and one along the Shikan River in Pingwu county. Most of the basic data in Table 1 were obtained from reconnaissance records by many experts and institutes, while the classification of the landslide dam type and the estimated dam failure mode were evaluated by the authors on the basis of the following criteria.

The statistical analysis undertaken was related to the 32 landslide dams for which relatively complete data were available (Fig. 3). The landslide dam concentration (N) is defined as the number of landslide dams for a sequence of concentric parallel bands 1 km wide, extending outward from the surface projection of the fault plane. Figure 4 shows the relationship between the landslide dam concentration and the distance from the surface projection of the Yingxiu–Beichuan fault plane (D_p). The figure shows that the highest concentration values are close to the fault (8 at $D_p = 1$ km), decreasing to 0 at >13 km. Without a theoretical basis for choosing a particular function form for the relation between N and D_p , it was found that the relation between N and D_p empirically fits best with a regression equation with a logarithmic form (see Fig. 4). Keefer (2000) undertook a similar statistical analysis of an earthquake-induced landslide distribution in California in 1989.

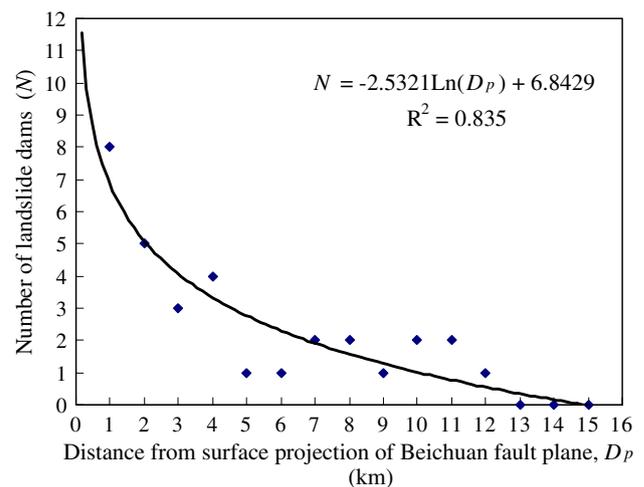
Fig. 4 Landslide dam concentration (N) versus distance from the Yingxiu–Beichuan fault (D_p). The solid line is the best-fit regression line, which has a logarithmic form

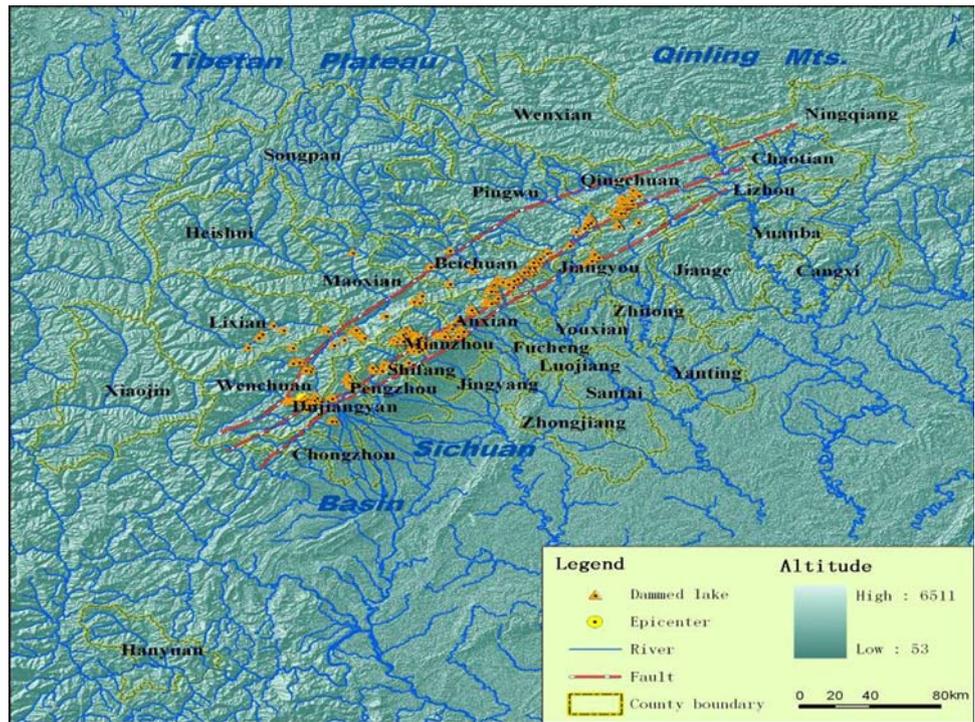
Fig. 5 The distribution of some of the landslide dams triggered by the Wenchuan earthquake (source: Institute of Mountain Hazards and Environment in Chengdu)

The 256 landslide dams identified after the Wenchuan earthquake were combined with a digital elevation model (DEM), generated by the Institute of Mountain Hazards and Environment in Chengdu (Fig. 5). Statistical analysis indicates that 43% of the dams are located in areas less than 5 km from the Yingxiu–Beichuan fault and 26% 5 to 10 km away from the fault.

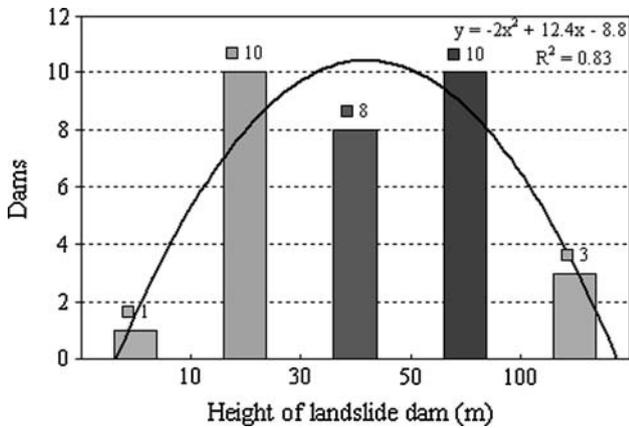
Fig. 6 Variation of the height of the landslide dams

dammed site, area of the watershed and its hydrologic regime (Nicoletti and Parise 2002). The volumes of the 32 landslide dams studied and the lakes behind them are very variable. The possible natural maximum capacities (the impounded water volumes at full lake level) of the barrier lakes given in Table 1 have been estimated from the heights of the landslide dams and the upstream topography. As seen in the table, the Tangjiashan landslide dam is the largest with a volume of 2.04×10^7 m³ while Yanziyan is the smallest with a volume of 6×10^3 m³. There are three landslide dams with volumes larger than 1×10^7 m³ and six barrier lakes with an estimated maximum capacity of more than 1×10^7 m³. The landslide dams vary widely in height, from 8 to 124 m (Fig. 6).

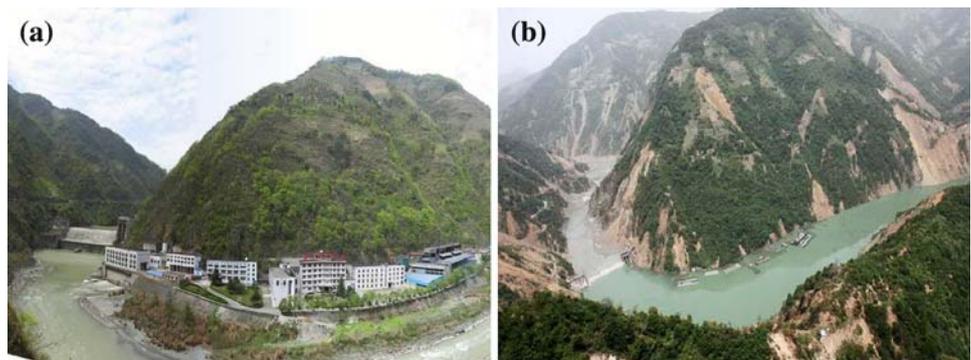
Fig. 7 Hydropower station upstream of the Kuzhuba landslide dam along the Jian River. **a** Before the Wenchuan earthquake. **b** After the Wenchuan earthquake

A barrier lake generated by a landslide dam will submerge the upstream area; an example of the impact of landslide dams in the upstream area is shown in Fig. 7.

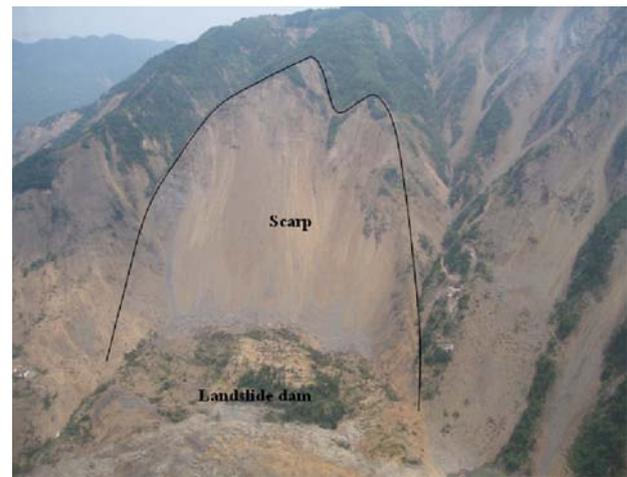
Fig. 8 Helicopter view of the Tangjiashan landslide dam

The Tangjiashan landslide dam, located in the upstream section of the Jian River in Beichuan county was the largest and most dangerous landslide dam created by the Wenchuan earthquake. The dam crest extended approximately 600 m across and 800 m along the valley (Figs. 8, 9). The height of the dam varied from 82 to 124 m; from a rough calculation using the profiles its volume was estimated to be $2.04 \times 10^7 \text{ m}^3$.

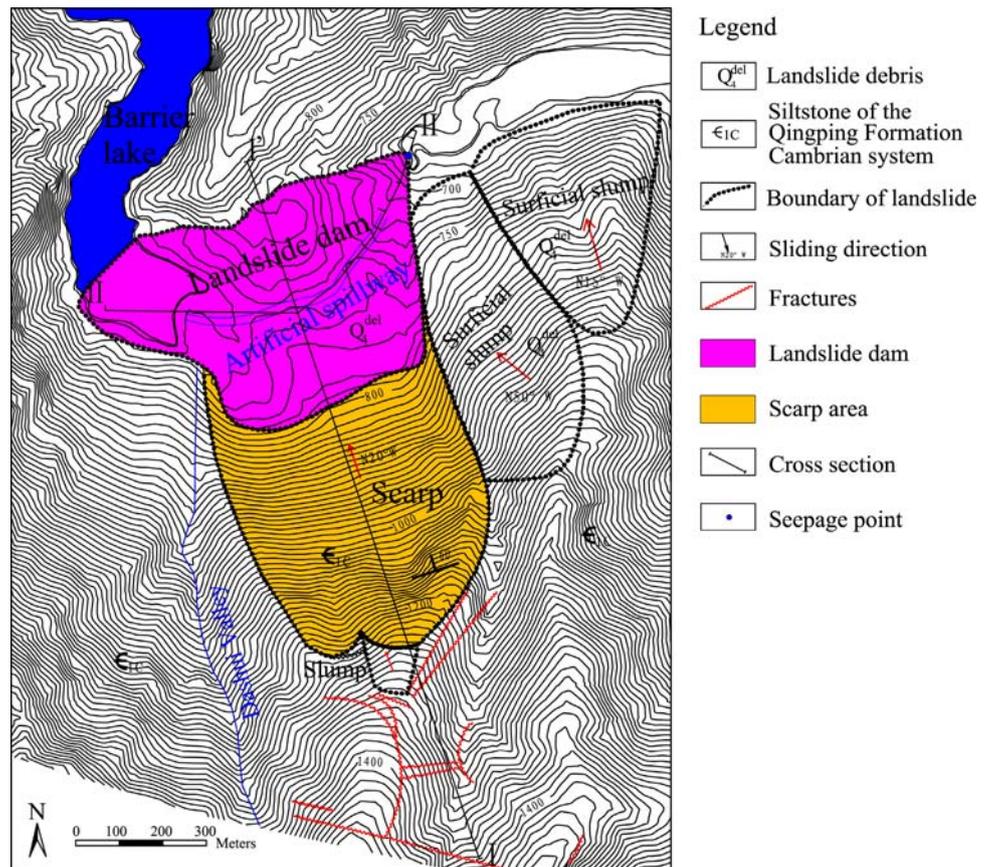
Fig. 9 Engineering geological map of the Tangjiashan landslide (modified from Hu 2008)

The Tangjiashan landslide dam was caused by a rock slide in interbedded soft rock and hard rock strata, which were formed from grayish black siltstone of the Qingping Formation of Cambrian age. According to the eye witness's description, the landslide occurred almost at the same time as the earthquake and traveled for a vertical distance of 540 m within 1 min, i.e. with an estimated speed of 10 m/s. The very large, steep scarp can be observed in Figs 8 and 10. Another characteristic of the landslide is that it ran up the other side of the valley. With reference to the aforementioned classifications, it fits both Type I and Type II. The dam basically has a three-layered structure (Fig. 11). The top layer is composed of fragmented rocks with soil; the middle layer contains mainly boulders and blocks while

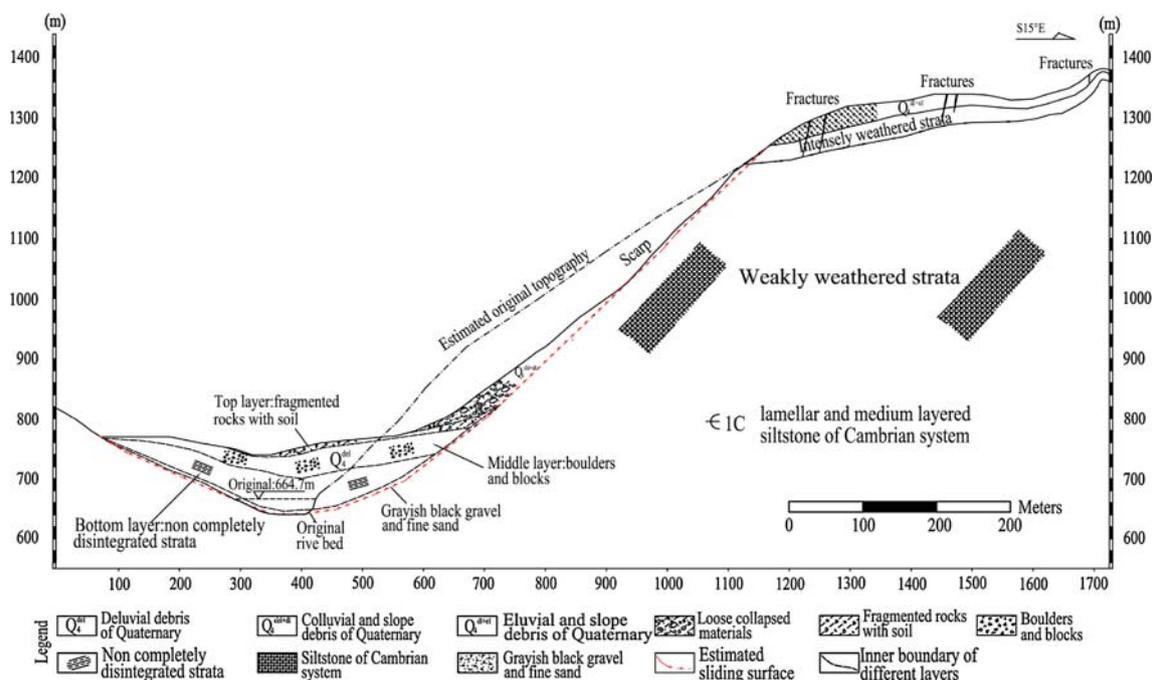
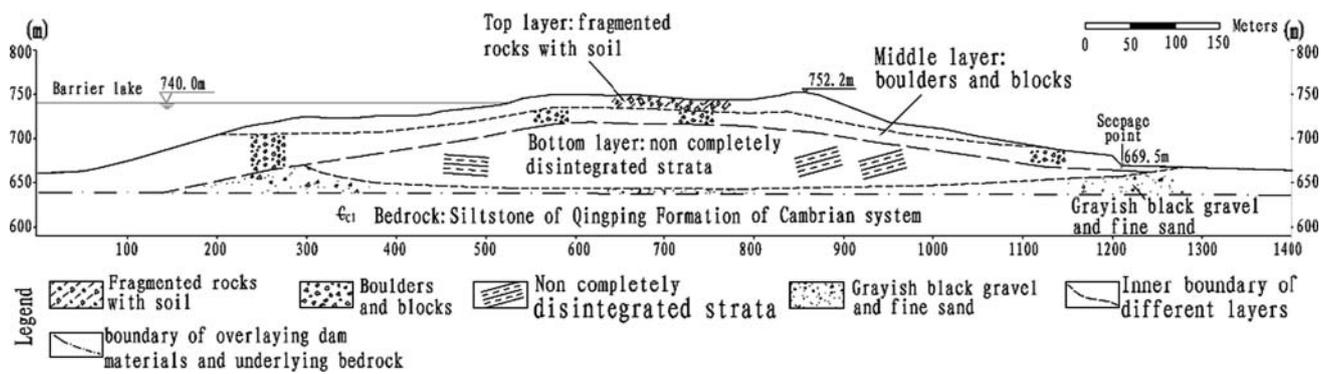
Fig. 10 Engineering geological profile I-I' through the Tangjiashan landslide and landslide dam. The dam has a three-layered structure. The original water table of Jian River at the dam site was 664.7 m.

Some fractures can be seen at the top of the slope, c. 1,300 m. (modified from Hu 2008)

the bottom layer consists of very weathered strata which retain their original structure. The average size of the boulders is 2 to 3 m with a maximum of 5 m. The blocks vary from 0.2 to 1.5 m. The top layer and middle layers comprise approximately 10% boulders, 60% blocks, 20% fragmented rocks, and 10% soil. Consequently, the bottom layer is relatively more consolidated and has a lower permeability than the middle and top layers.

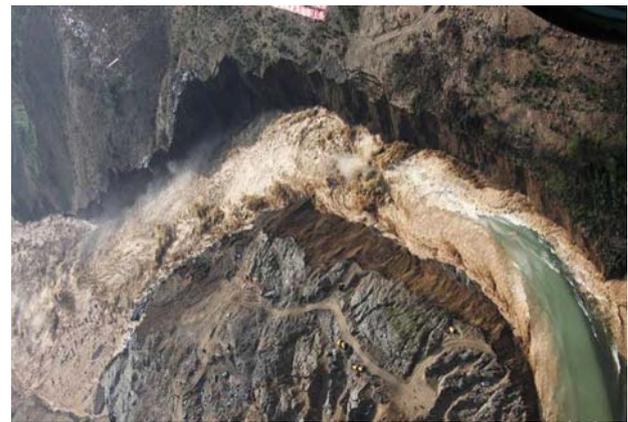
Fig. 12 Helicopter view of the artificial spillway in the Tangjiashan landslide dam

Fig. 13 Impounded water flowing through the artificial spillway. Taken at 11:00 (Beijing time) 10 June 2008 when the discharge reached its maximum (source: Liu 2008)

In this crucial situation, the Chinese government made the decision to build an artificial spillway by excavation and blasting. Artificial breaching was considered to be the only means of avoiding uncontrolled outburst flooding (Korup 2002). In order to alleviate the dam-break flood risk, artificial spillways were created by excavator or blasting to release some of the impounded water. On the basis of the information provided by Liu (2008), the emergency engineering was carried out by the army, from 25 May 2008 onwards. After 7 days and 6 nights of continuous work, a 475 m long and 12–13 m deep spillway had been created (Fig. 12). The elevation of the spillway was 740 m near the entrance and 739 m near the exit. On 7 June 2008, the water level of the barrier lake rose to 740.4 m, a little above the elevation of the entrance of the spillway, so the water began to overflow through it. At that time, the volume of the lake was about $2.29 \times 10^8 \text{ m}^3$. The discharge of the spillway changed dynamically with the change of the water level of the barrier lake. The maximum discharge was $6,500 \text{ m}^3/\text{s}$ on 11 June (Fig. 13).

the water level had been reduced from 743.1 (the highest value) to 714.3 m. The corresponding volume of the barrier lake decreased from $2.47 \times 10^8 \text{ m}^3$ to $0.86 \times 10^8 \text{ m}^3$ and the people who had been evacuated returned to their homes.
